## APPRAISAL REPORT

# Port Bailey (former Seafood Plant)

Dry Spruce Bay near Kupreanof Strait on the northwest coast of Kodiak Island  
Kodiak, Alaska

NPA Job Reference No: 19-2040-GW

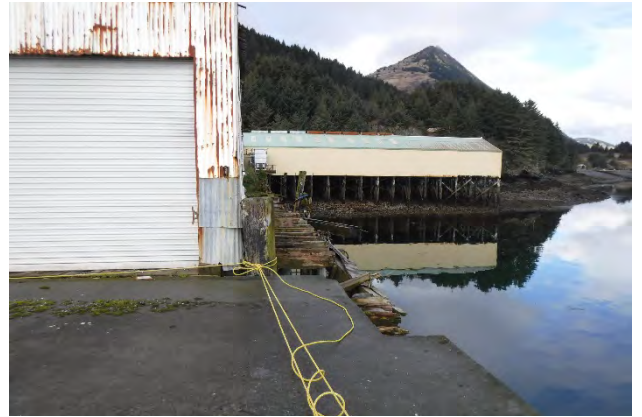
South view of missing/damaged dock

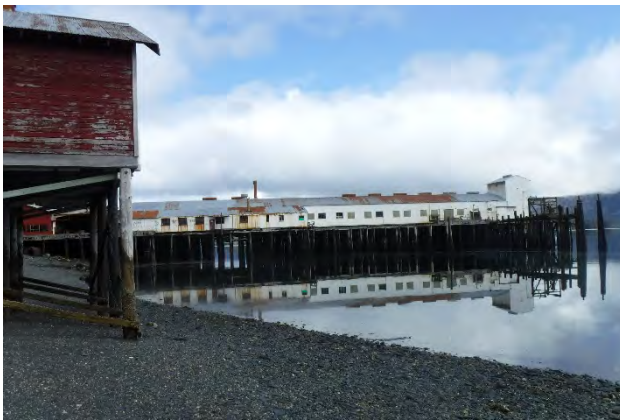
Northwest view towards the Cannery

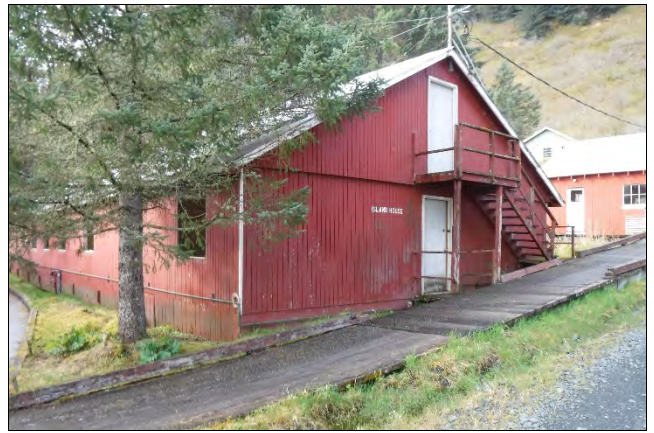
Island House (5) Not windows removed

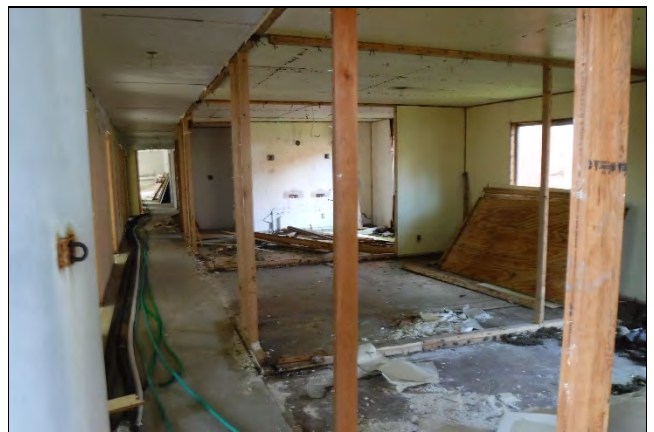
Island House (Window removed)

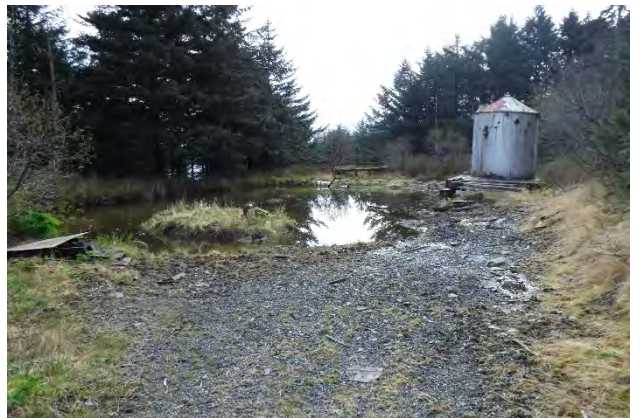
Environmental clean-up area
